**CHARACTERISTICS AND ENGINEERING PROPERTIES OF THE  
SOFT SOIL LAYER IN HIGHWAY SOIL SUBGRADES**

**Research Report**  
**KTC- 06-13/SPR 270-03-1F**

June 2006

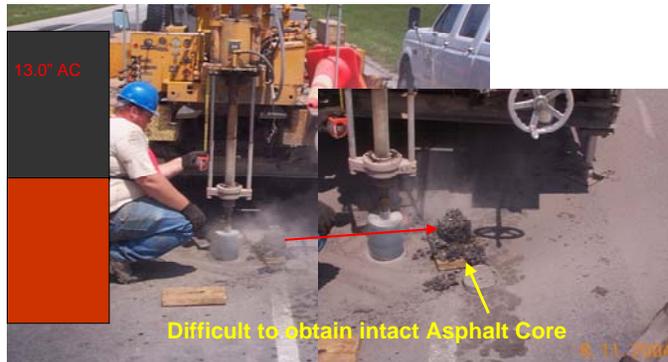
Figure 62. Asphalt core sample completely fell apart during recovery.
